Natural Water Retention Measures

Case Study The Odelouca River

CS: Odelouca River, Portugal

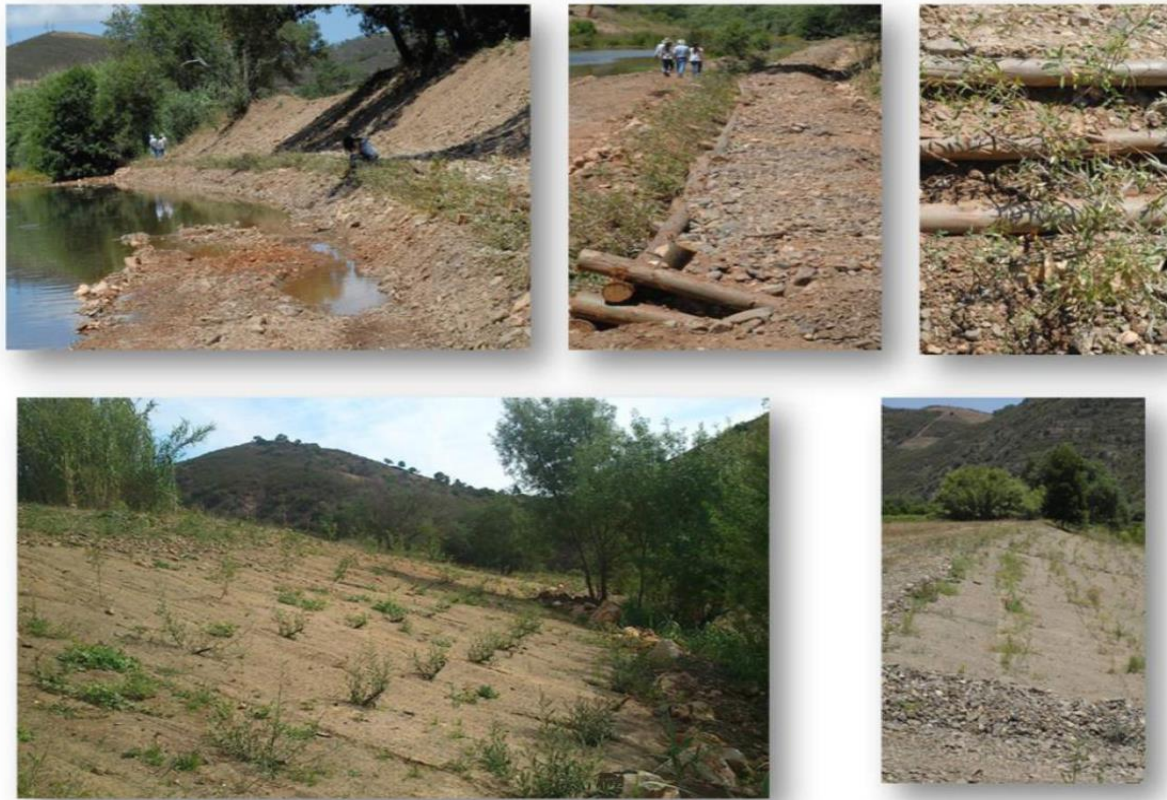
Figure 1 Examples of bank stabilisation techniques used at the Odelouca rehabilitation sites. The top photographs show the bank corrected by construction of a crib wall. The lower photographs show a bank that has been resectioned to give a more natural profile, covered with geotextile and planted with a selection of native species.

geotextile; 100% coco fibre with 2 polypropylene nets); ii) construction of a crib wall and placement of stone filled gabions to stabilise river banks (vegetated rock armour, live cribwalls (i.e Krainer wall), and vegetated gabions); iii) planting of rehabilitated banks with native plant species, collected from cuttings and seeds in the area and grown on in local nurseries (e.g. Tamarix, Oleander, buckthorn and ash); iv) construction of artificial islands in the river channel; v) clearance of invasive riparian plant species (<i>Arundo donax</i> and <i>Acacia sp.</i>).
--	--

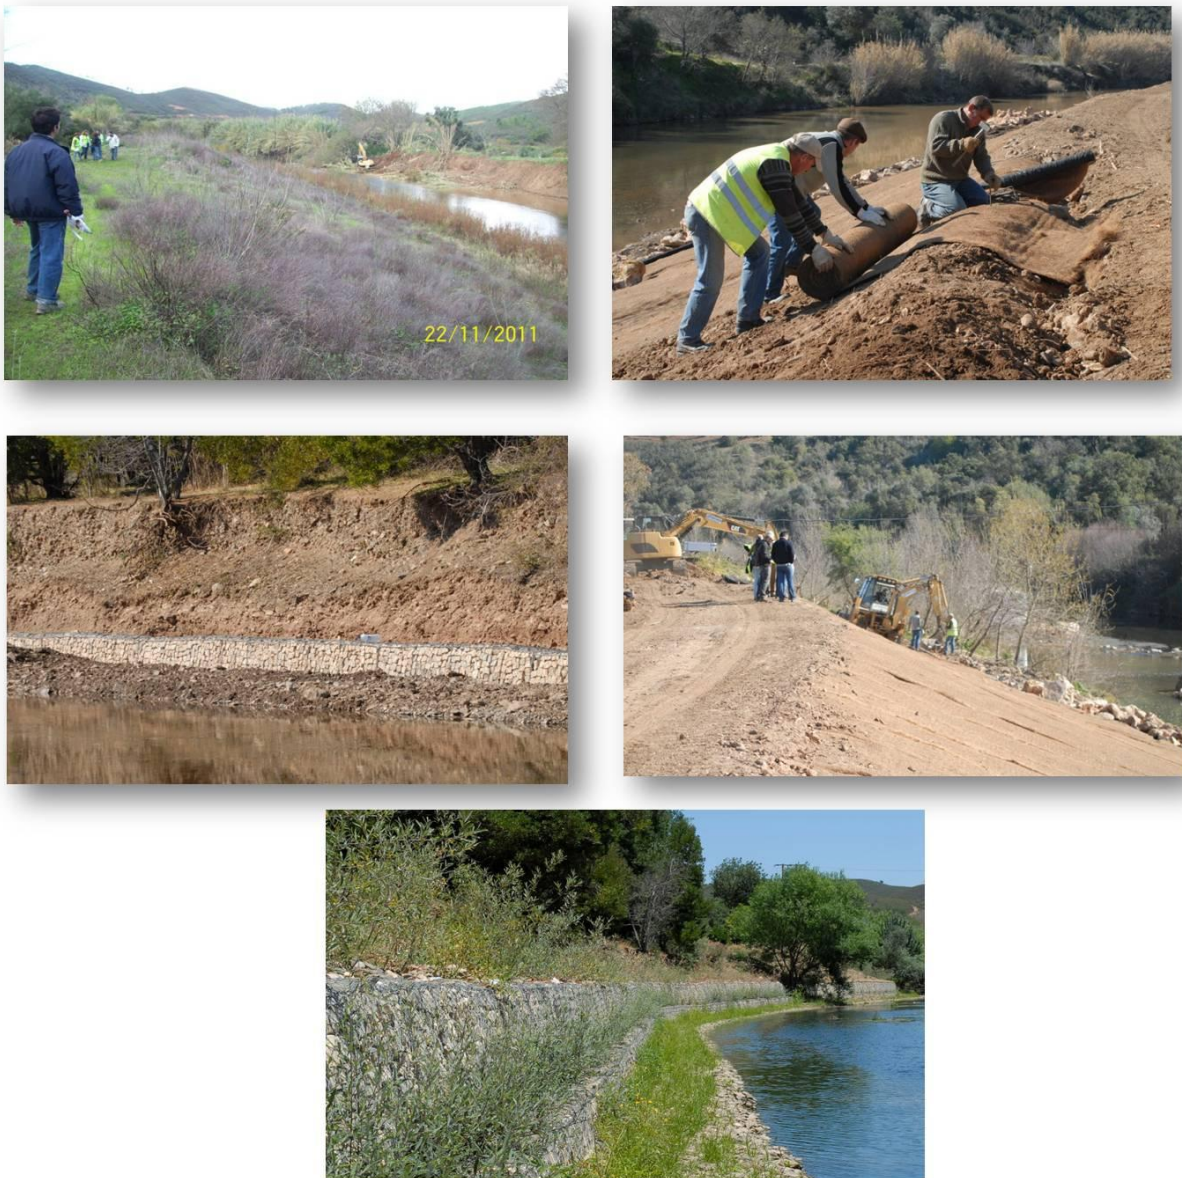
Figure 2 Pictures taken at the outset of the bioengineering works at the selected sites on the Odelouca – winter 2011 – 2012. Gabions (not a NWRM but a means to the implementation of one of them) had to be placed along the right banks at site M where (i) erosion was so intense and (ii) heavy machinery aggravated the situation that the bank was in danger of collapsing.
