# Experience in Wetlands restoration and conservation concerning natural water retention measures

Ministry of Environment and Water, Bulgaria

Szentendre, 28-29 January 2014

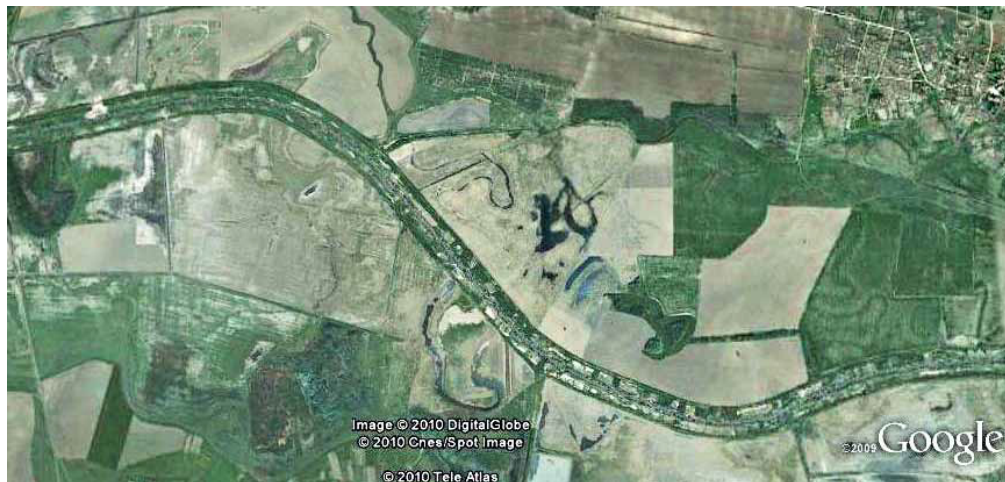
## Osam River near Obnova village before and after strenghtening

After river training, the coefficient of curvedness is 3 times shorter and the shortening of the river is more than 3 times. It could be assumed totally straightened.

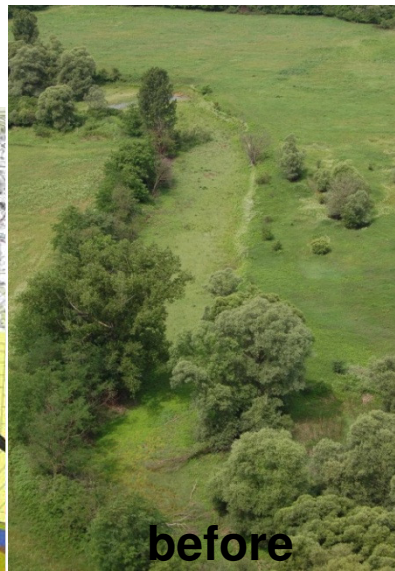
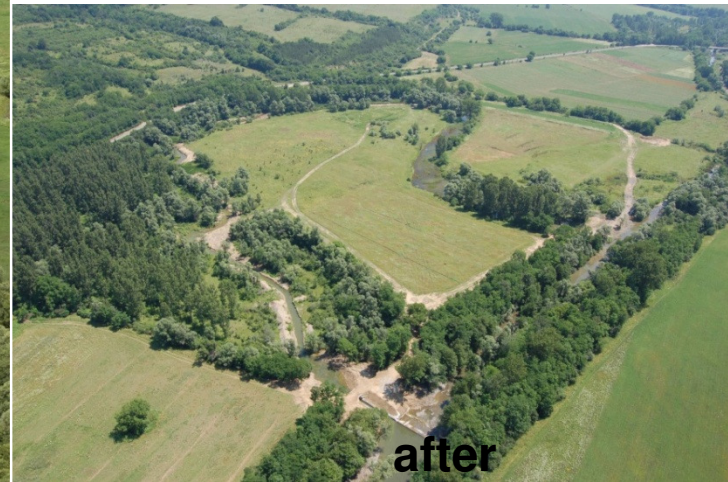
## Example 1 – Restoration of meander of Vesselina river, DRBD

- A project realized by WWF, Mindya village community
- Object: Remeandering of the Vesselina river with its former meander near the village.
- In the years when the meander have been cut off the river, the river have carved into the river bed nearly 150 cm deeper, it have been indispensable to build a threshold so that the water level to be raised at a point to enable water flowing back to its former bed.

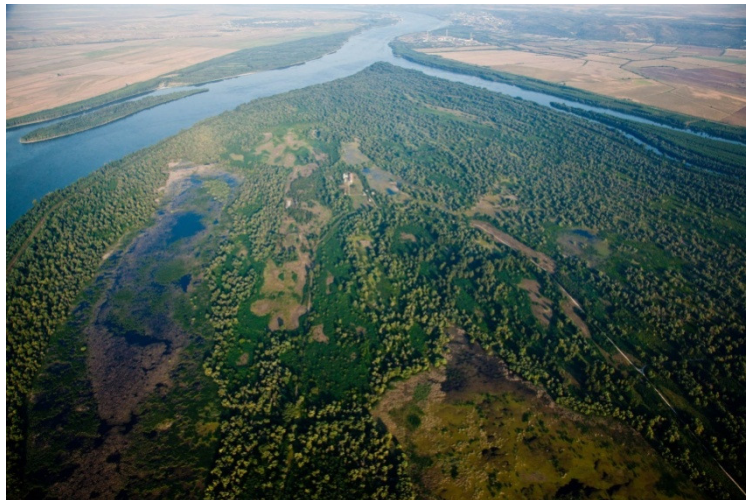
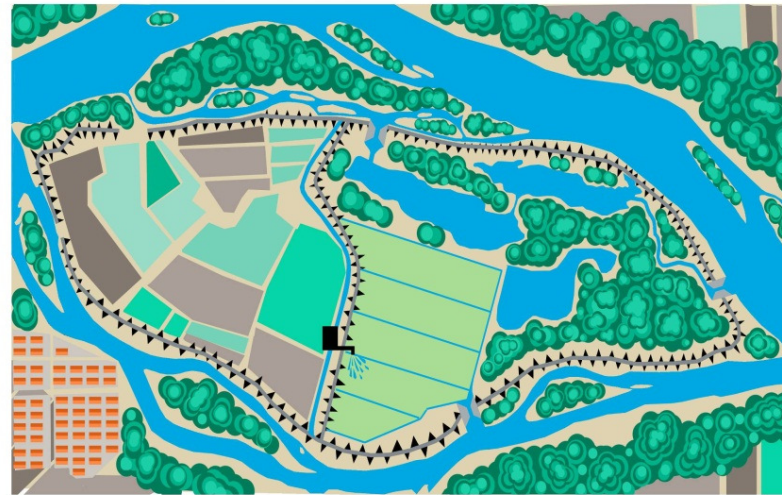
## Example 2 – Reconnection between the Danube River and the wetlands of Persin Island

Under this project the Danube dyke was open at three points and huge inlet structures (sluices) were built to ensure controlled water flow from the river to the wetlands. Adjacent arable lands are protected by intermediate dyke and drainage canal with drain pumping station.

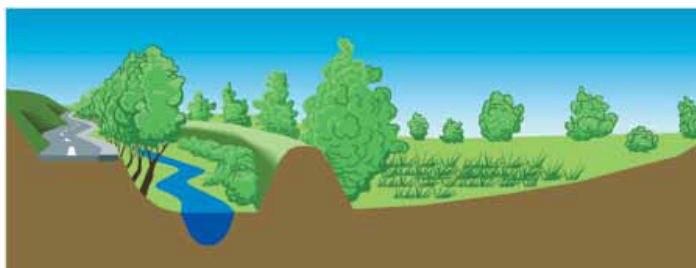
Average water level

- A project realized by Directorate of Natural Park Russenski Lom and WWF, funded by the German Federal Environmental Foundation (DBU).
- Nowadays river can overflow its banks, tease and soon after – to get back to its bed, without leaving inundated land.

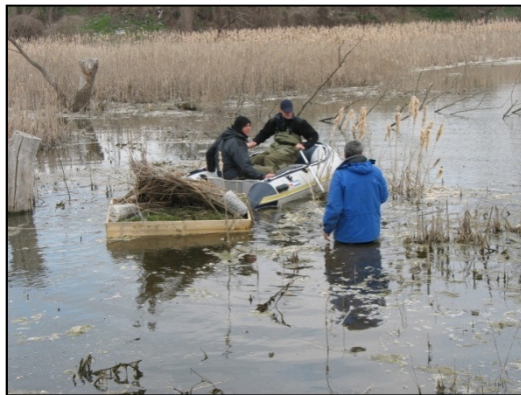
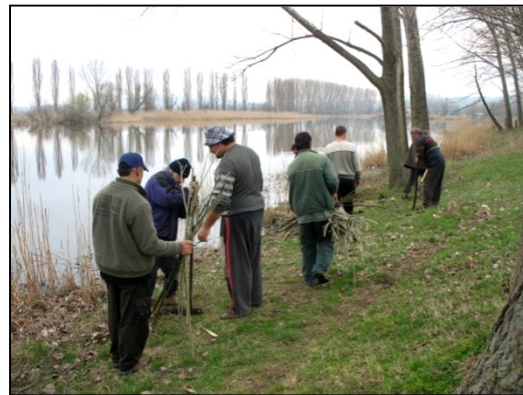
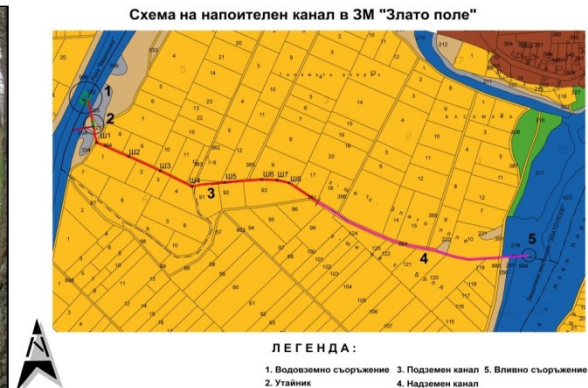
# Example 4 – Restoration, protection and sustainable development of Zlato pole

- Restoration Activities for restoration of a wetland near Maritza river.
- Objectives:
  - additional water storage quantities aiming to maintain the hydrological regime of the wetland;
  - restoration and protection of wet woods aiming protection of biodiversity.

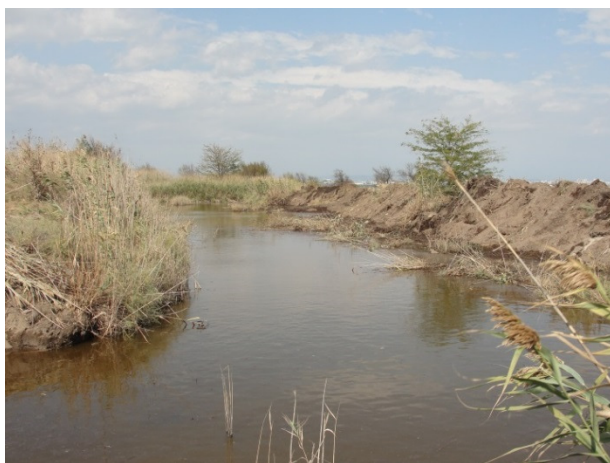
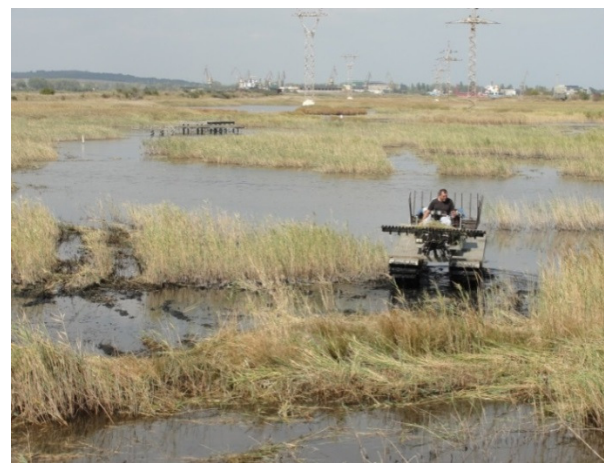
## Example 5 – Atanasovsko lake

- Project „Life for Bourgas Lakes“ funded by Life + Program - Bulgarian Society for the Protection of Birds - Atanasovsko lake /Ramsar site/ (Black sea district);
- ✓ Activities in restoration of the wetland zone;
- ✓ Activities in creation of new water storage volume near– aiming to enhance biodiversity of water ecosystem and so – diversity of protected birds.
- ✓ Restoration of the protection dyke and canal surrounding the lake

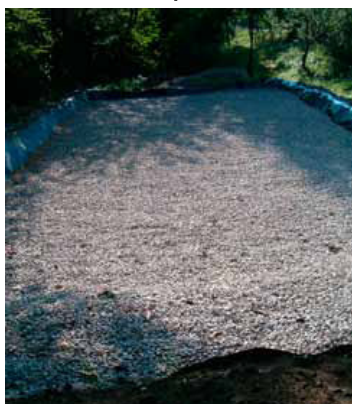
Final stage of the lagoon, 2006

- Example 1:** Lagoon for treatment of wastewater generated from a tourism utility in Falkovets village, Northwest Bulgaria (Danube river basin district)

Analysis of effluent, 2006:

Показател	1-ва категория	2-ра категория	3-та категория	Стойност на показателя		Намаляване на показателите (в%)
				преди пречистване	след пречистване	
БПК <sub>5</sub>	5	15	25	622 +/- 62	39 +/- 4	93,73
ХПК	25	70	100	1285 +/- 51	83 +/- 3	93,55
Нитрити (N – NO <sub>2</sub> )	0,002	0,04	0,06	0,703 +/- 0,080	0,176 +/- 0,080	74,97
Нитрати (N – NO <sub>3</sub> )	5	10	20	1,260 +/- 0,403	1,966 +/- 0,403	+56,03
Азот по Келдал органичен	1	5	10	20,0 +/- 0,1	2,3 +/- 0,1	88,5
Фосфор	0,4	2	3	8,478 +/- 0,280	3,847 +/- 0,280	54,62

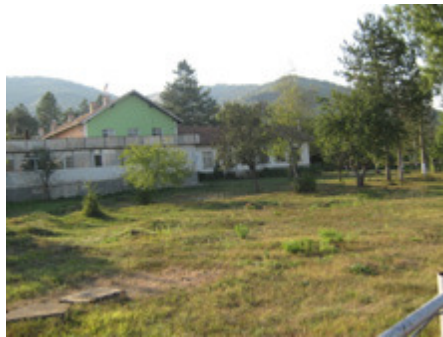
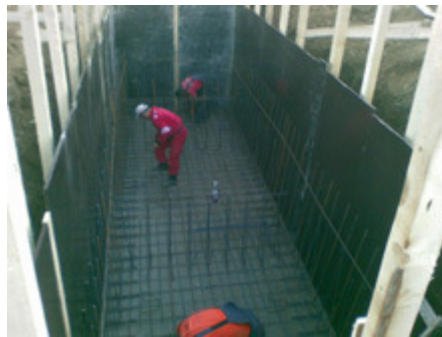
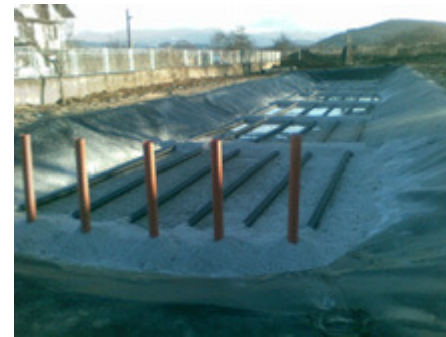
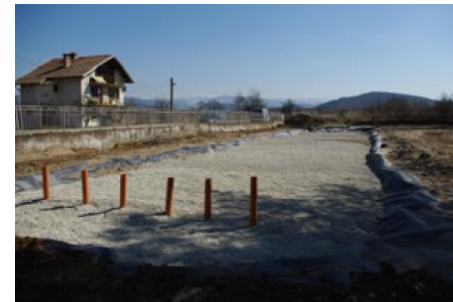
- **Example 2:** Lagoon for treatment of wastewater generated from a Home for mentally challenged /children with intellectual disability/ children in Vidrare village, Sofia district (Danube river basin district)

Surface A =  $3.5 \text{ m}^2/\text{PE} * 76 \text{ PE} = 266 \text{ m}^2$

Designed with vertical drainage:

- pretreatment stage - supplied with storage tank
- biological bed stage – gravel.

Effluent is discharged in the existing sewage system.
