Mountainous forest watershed management Governance in Greece

Alcala de Henares, 28-29 January 2014

1st NWRM Mediterranean Workshop

Post - fire water retention management: The case study of Ancient Olympia, Greece

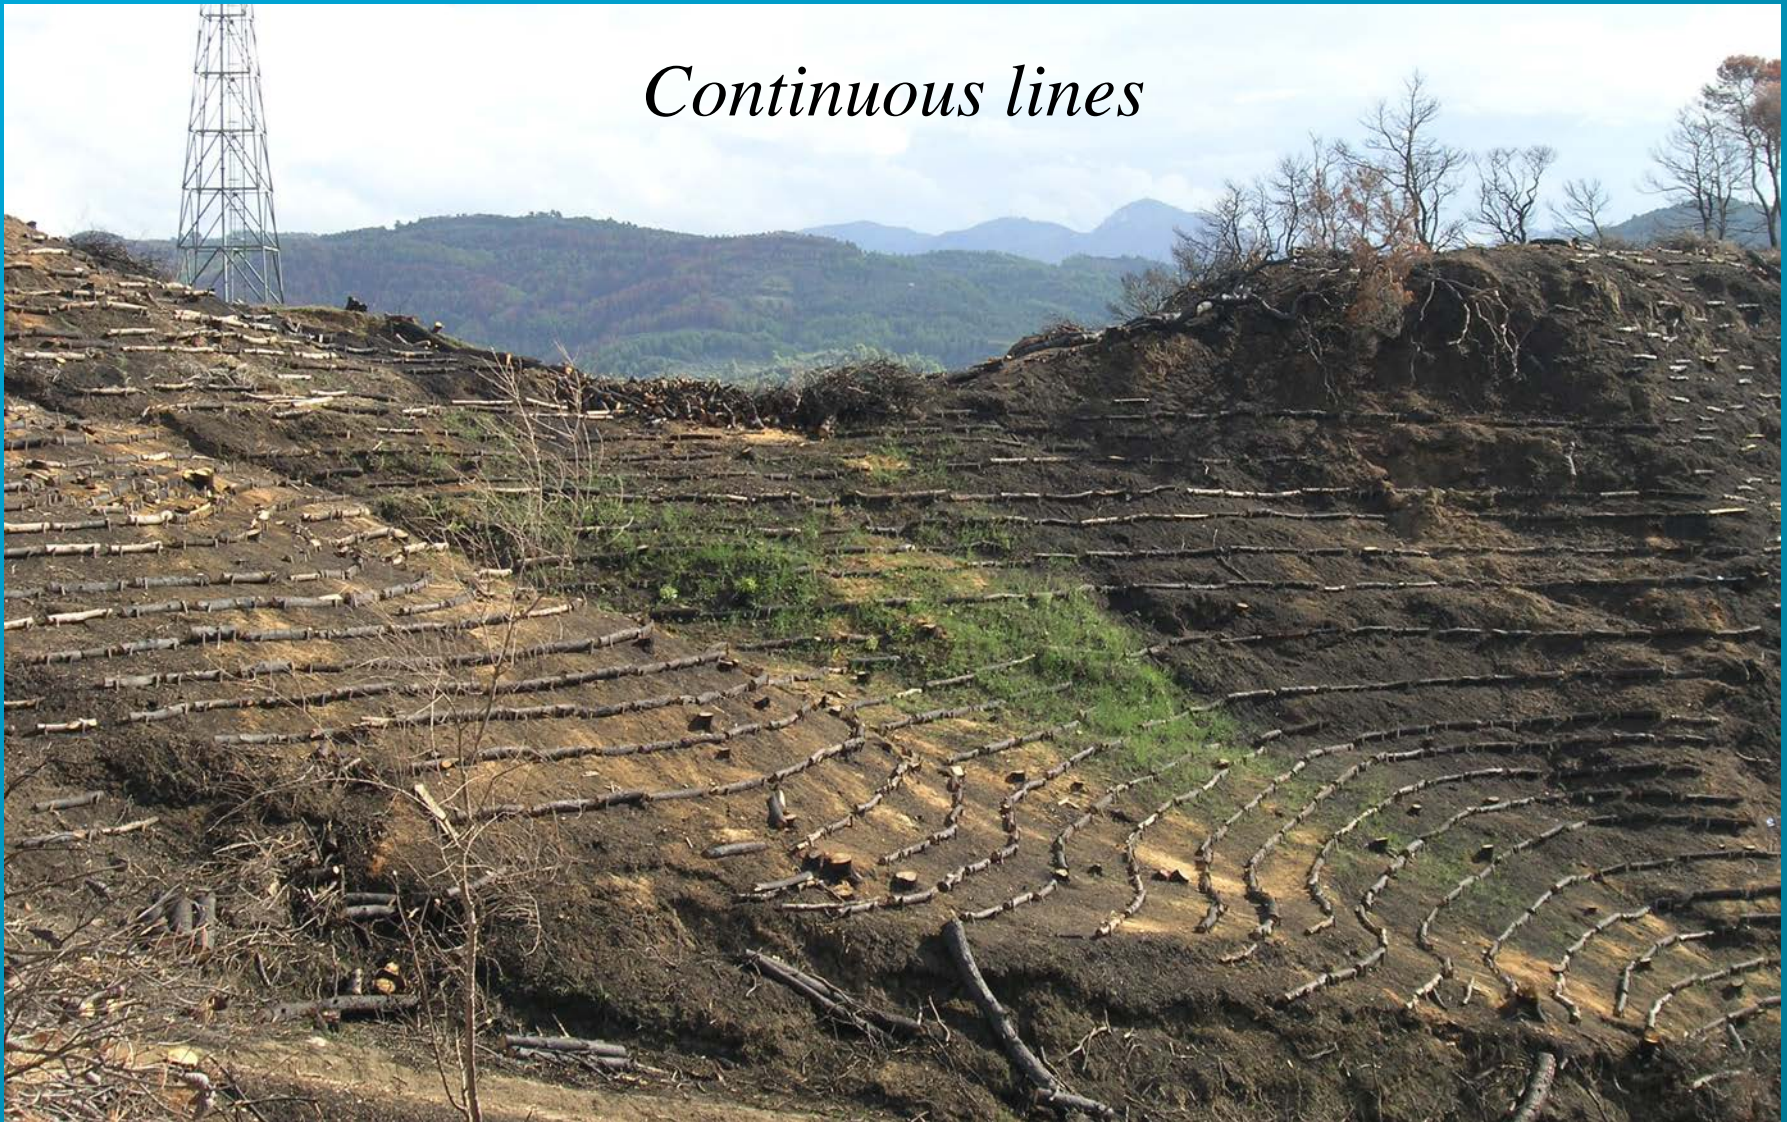
Continuous lines

- ✓ The log erosion barriers were constructed from the cutting trunks of burned Aleppo pine (*Pinus halepensis*) and cypress (*Cupressus sempervirens*) trees.
- ✓ They were fixed parallel to the contours of the slopes of the hills.
- ✓ They were secured on wooden stakes without any metal supports.
- ✓ Their distances were determined according to log characteristics and also to topographic and hydro-meteorological conditions of each site they secured.
- ✓ The log barriers formed continuous or empty-space lines for better fulfillment of aesthetic requirements of the area.
- ✓ They also placed in a “mosaic design” consisting from single or double in height logs (one over the other) according to the gradient of the slopes.

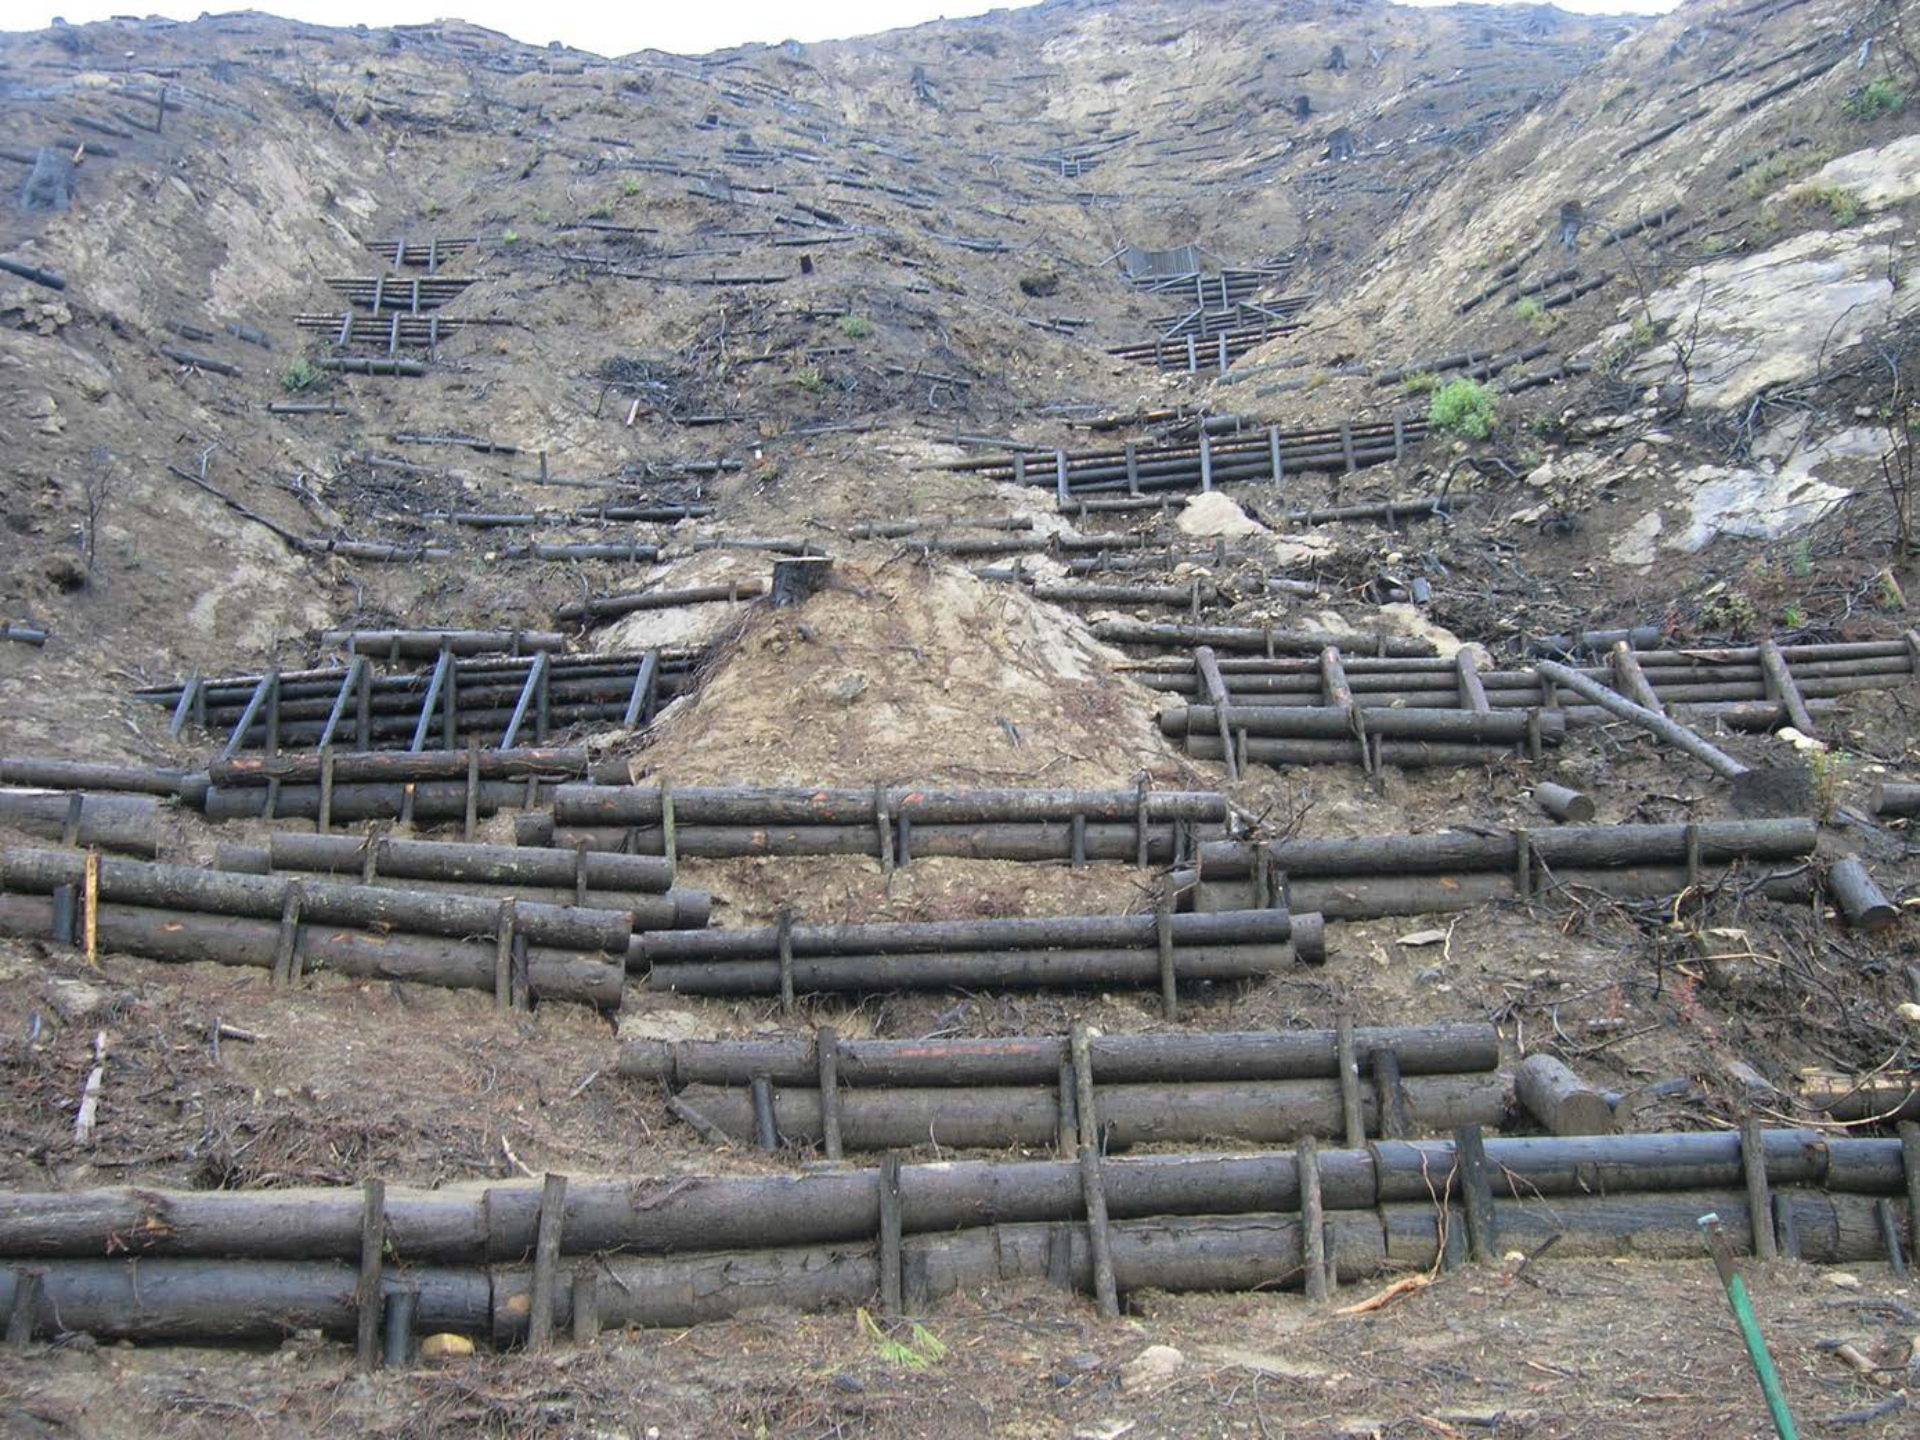
Gully and small stream channel check dams

- ✓ Wood-made check dams were selected for the same reasons concerning the log barriers.
- ✓ They were built perpendicularly to the main channel of the stream or the gully.
- ✓ The construction cross-sections of these works were selected according to their morphological and hydro-geological characteristics.
- ✓ Twenty-six check-dams were constructed, mainly on the south slope of Kronios hill facing the ancient Stadium, where there had been a landslide after a fire in the year 1932. The check dams prevent any new massive soil movement that would cover the Stadium.

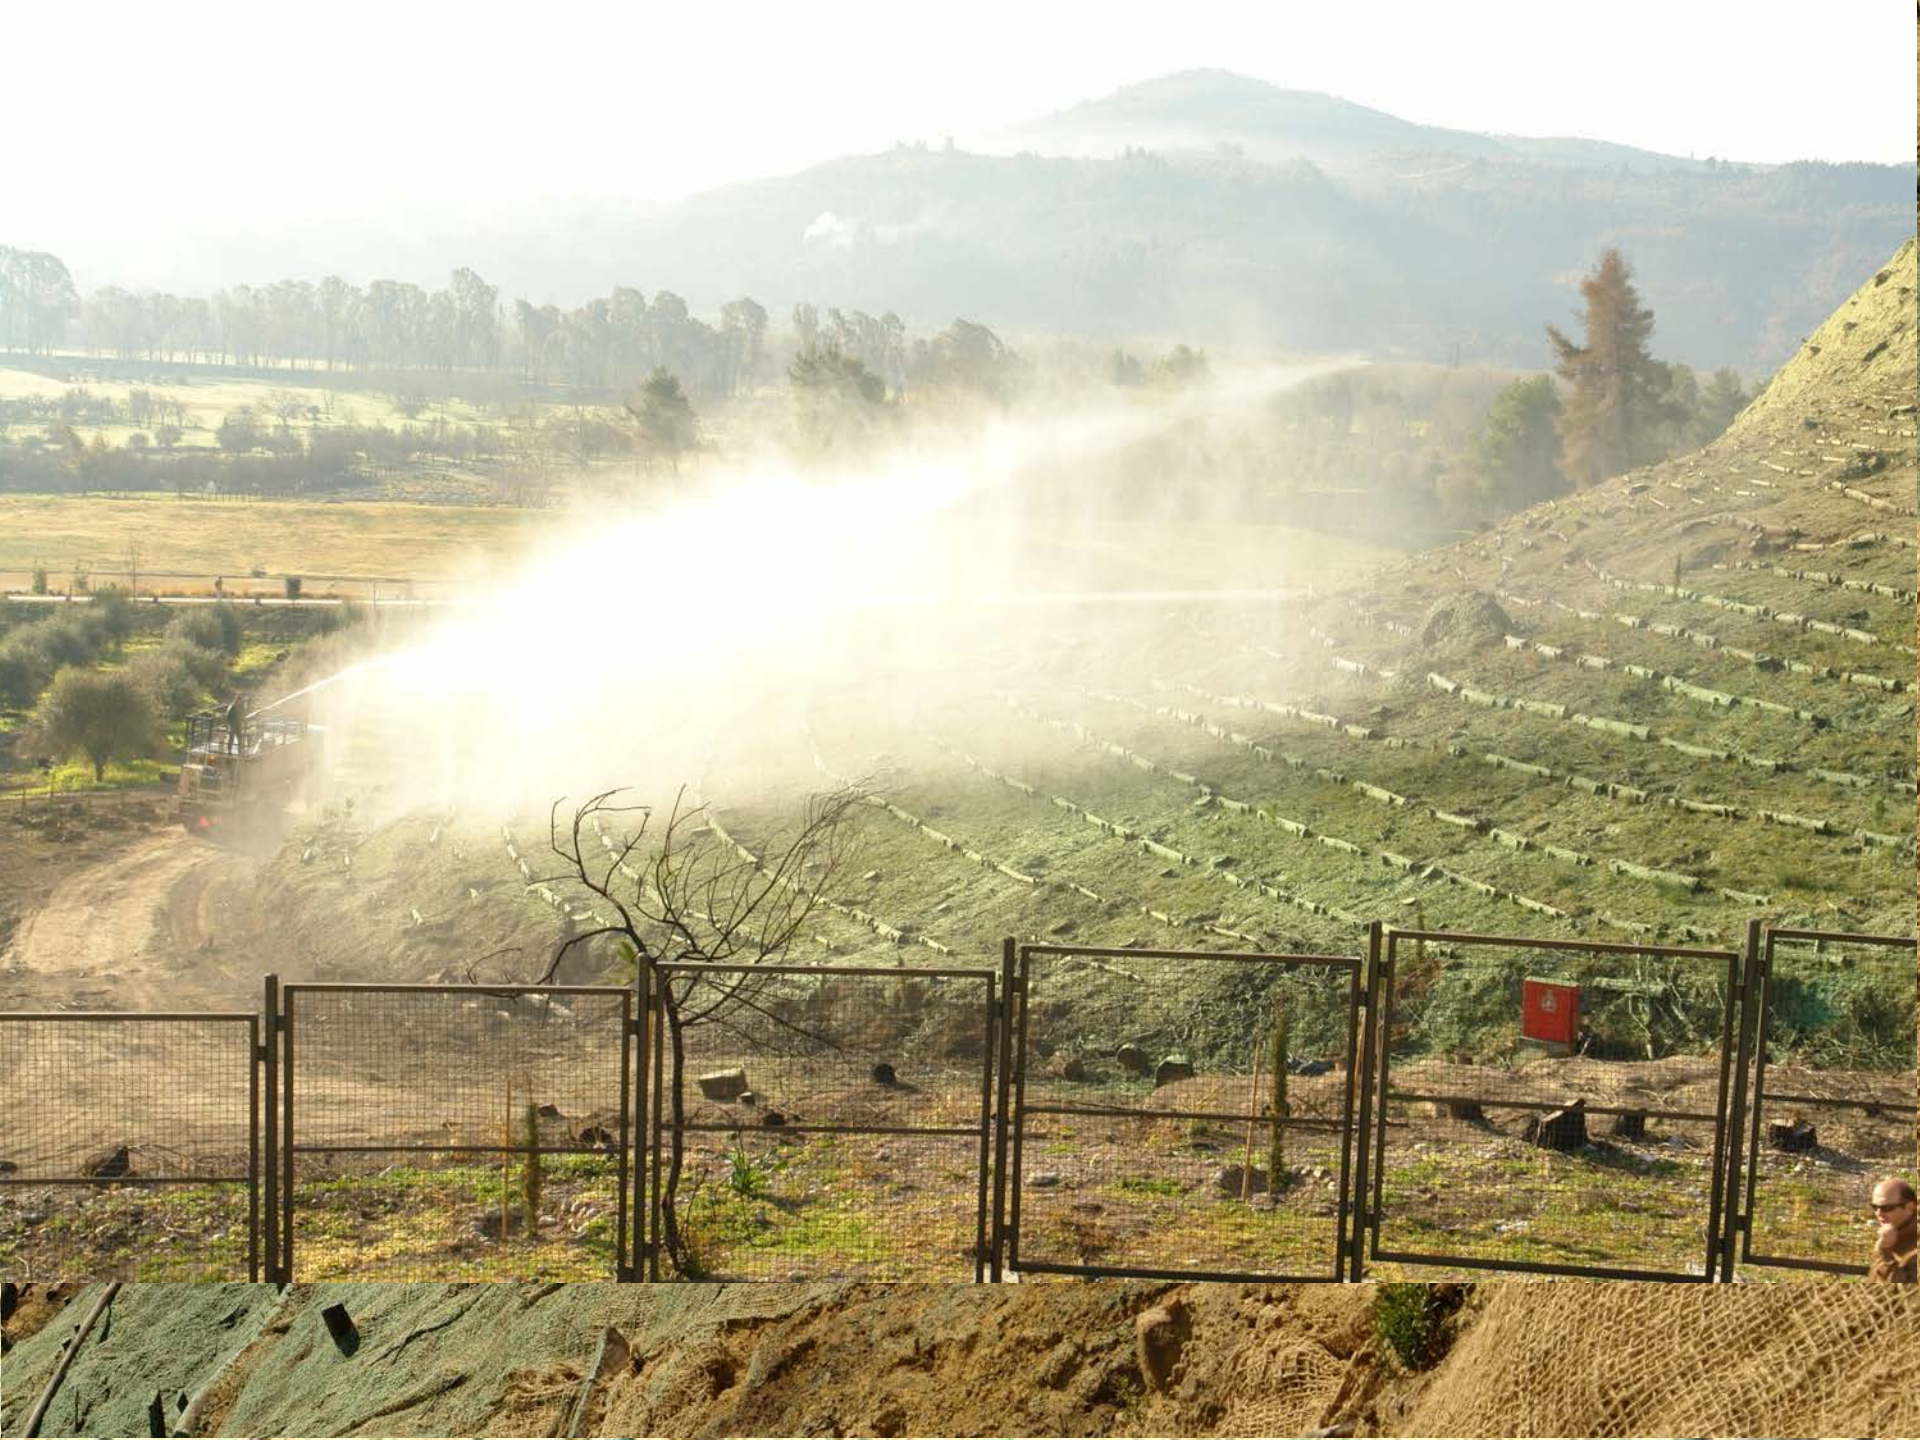
Hydro-seeding technique

Hydro-seeding technique was not applied to the total burned area but only to 21 ha and mostly on the steep slopes with the following mixture:

Water	20 m ³ /Ha
Fertiliser N:P:K 6:48:6	400 Kg/Ha
Glue	10-170 Kg/Ha
Fibre wood	1800 Kg/Ha
Organic soil improver	400 kg/Ha
Seeds	200 Kg/Ha

Hydro-seeding with the particular technology of the machinery used and with the help of hosepipe reached the 120 meters in length and at 90 meters elevation difference.

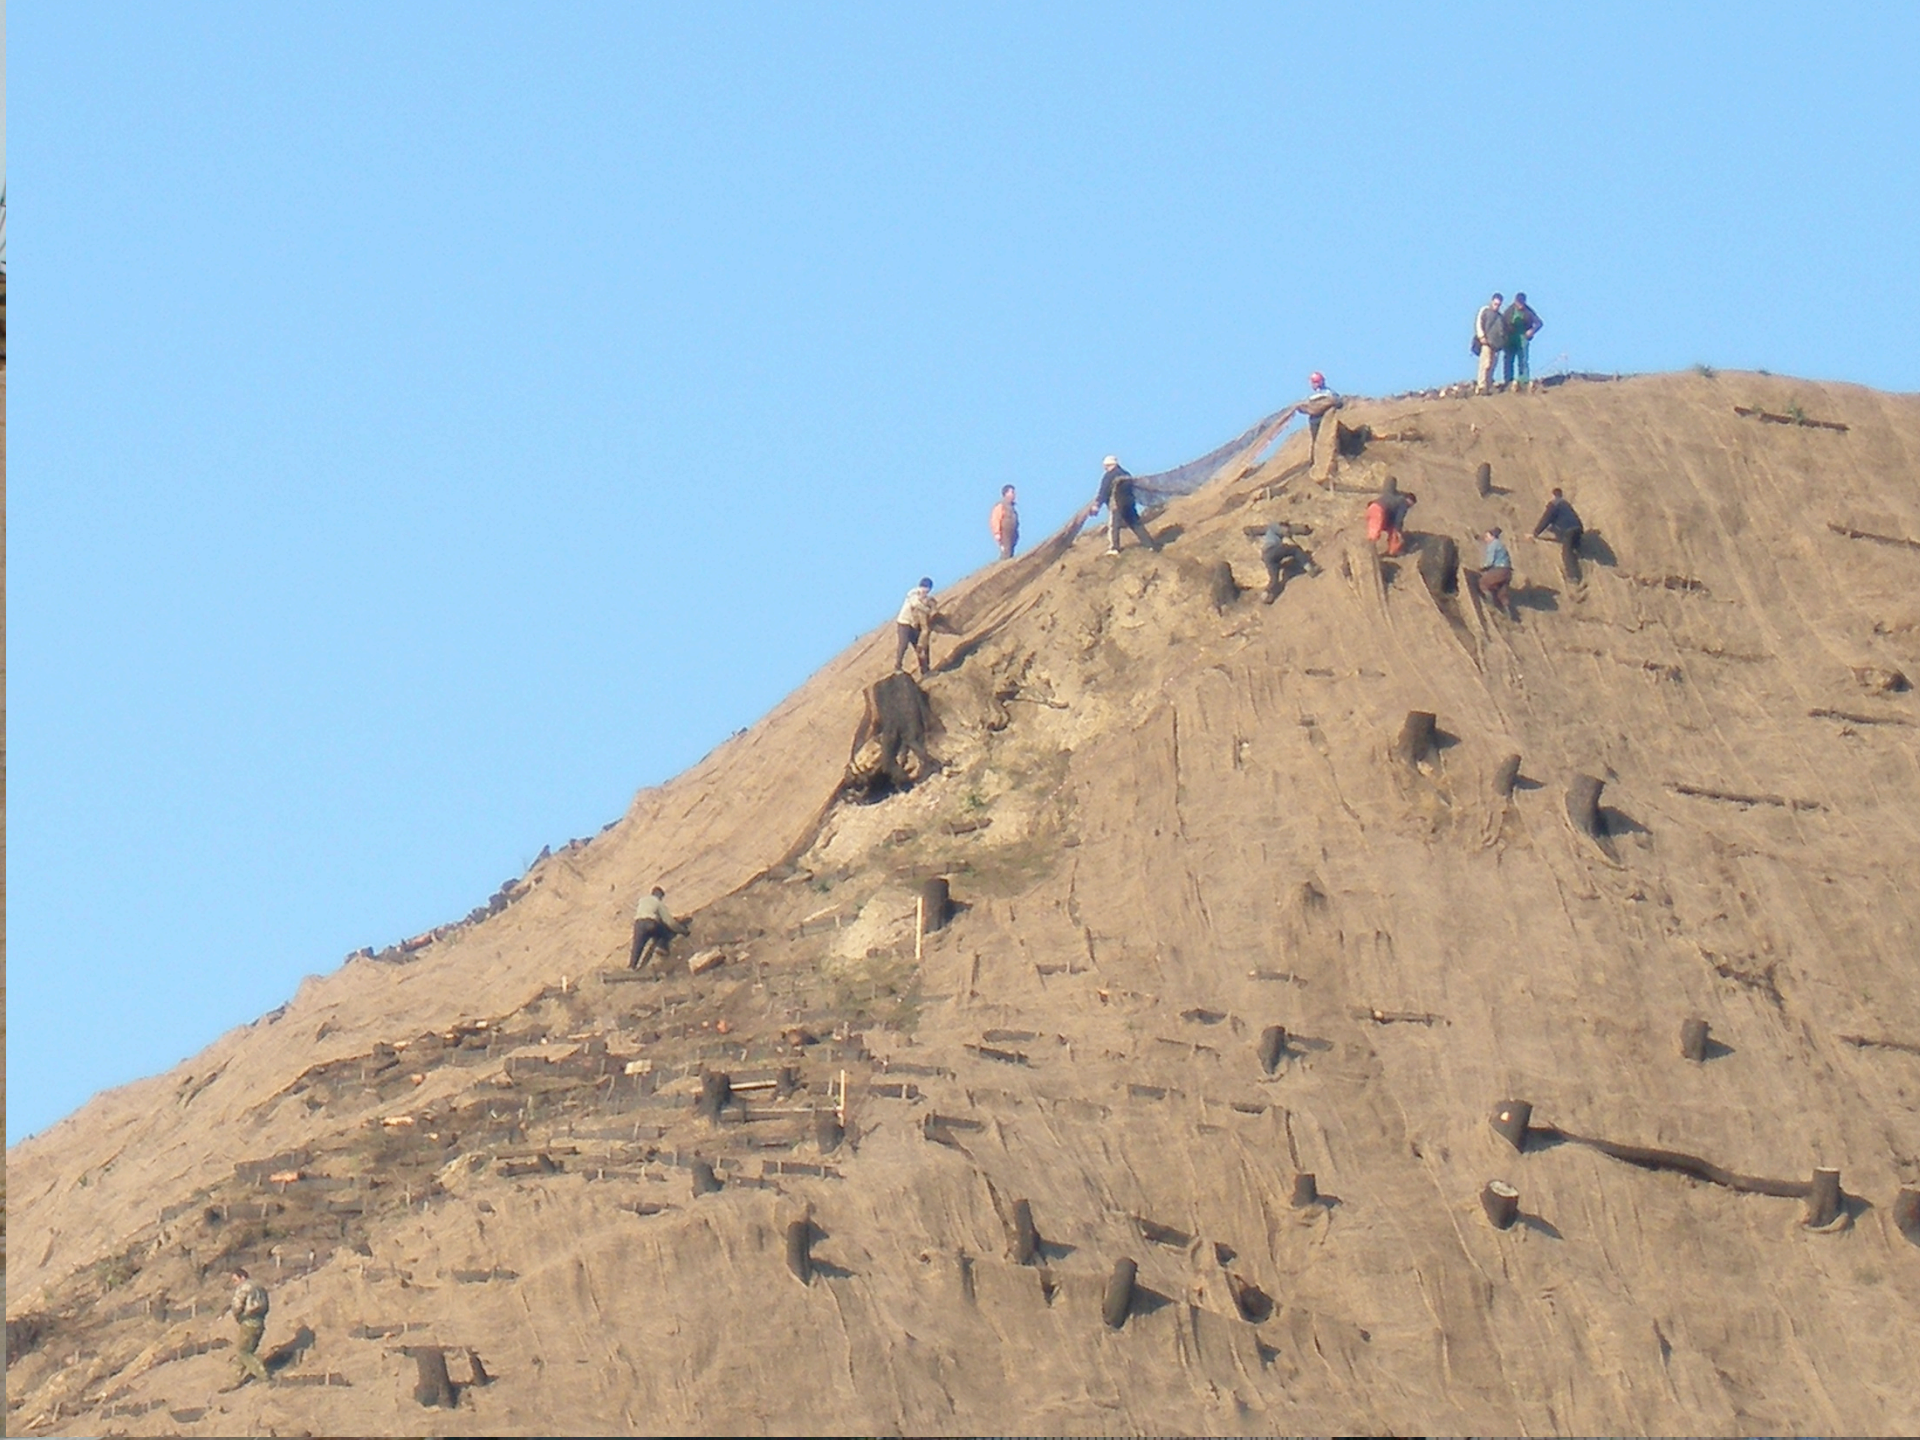
Application of the jute geotextile (very steep slopes)

- ✓ The jute was used in order to cover the soil before the application of hydro-seeding.
- ✓ In some cases the jute was applied even between log erosion barriers.
- ✓ The jute that was used is manufactured 100% from plant materials and it was biodegradable in 4 years time.
- ✓ Its role is double: it retains and protects the surface of the soil and provides favorable micro-environment for the plants because of humidity retention and shading.
- ✓ Jute was fixed with small metal forks for better contact with the soil.

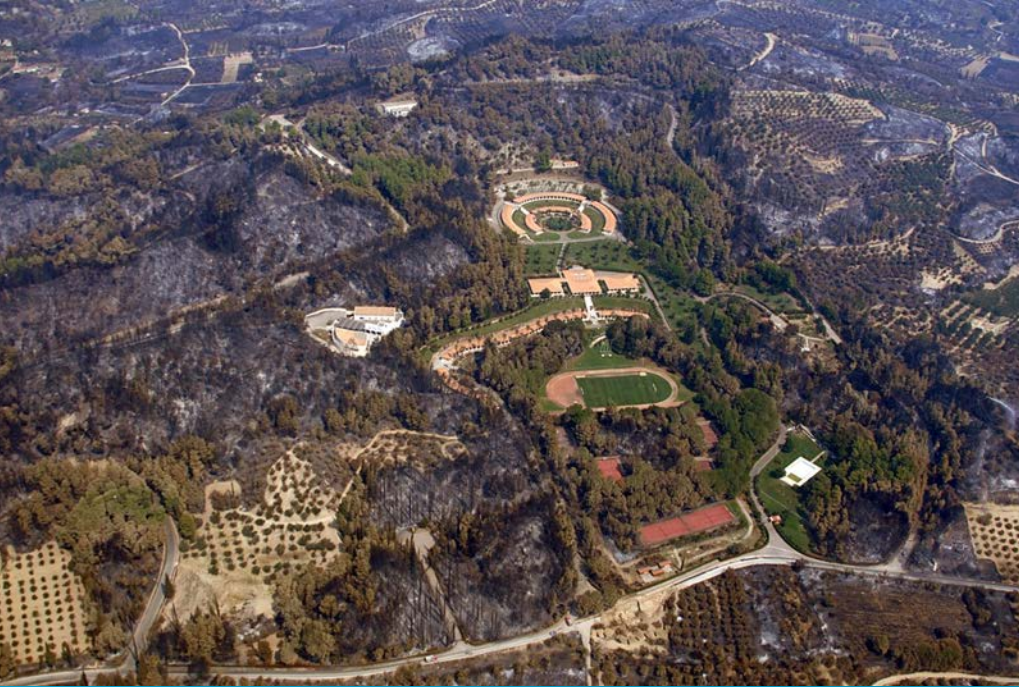
General view of the area a
day after the fire occurred
(August 2007)

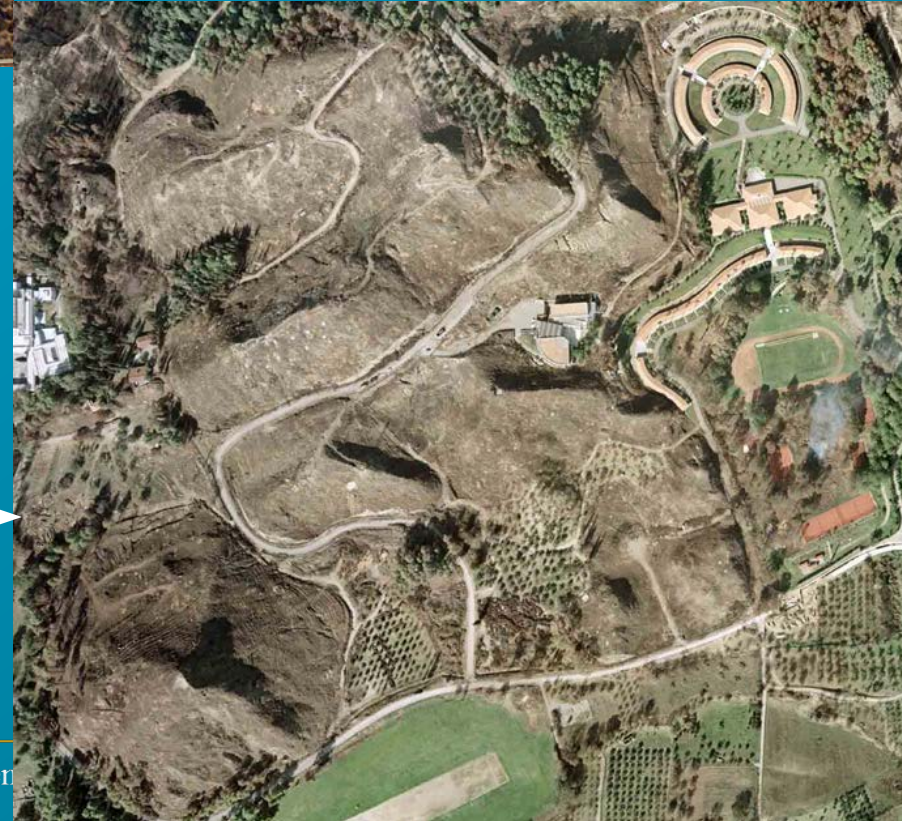
General view of the area
after the completion of the
works (January 2008)

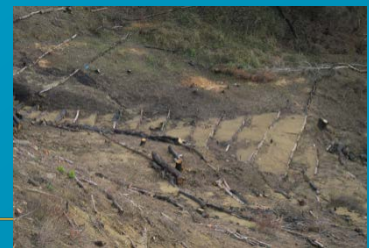
Percent (%) of the soil retained

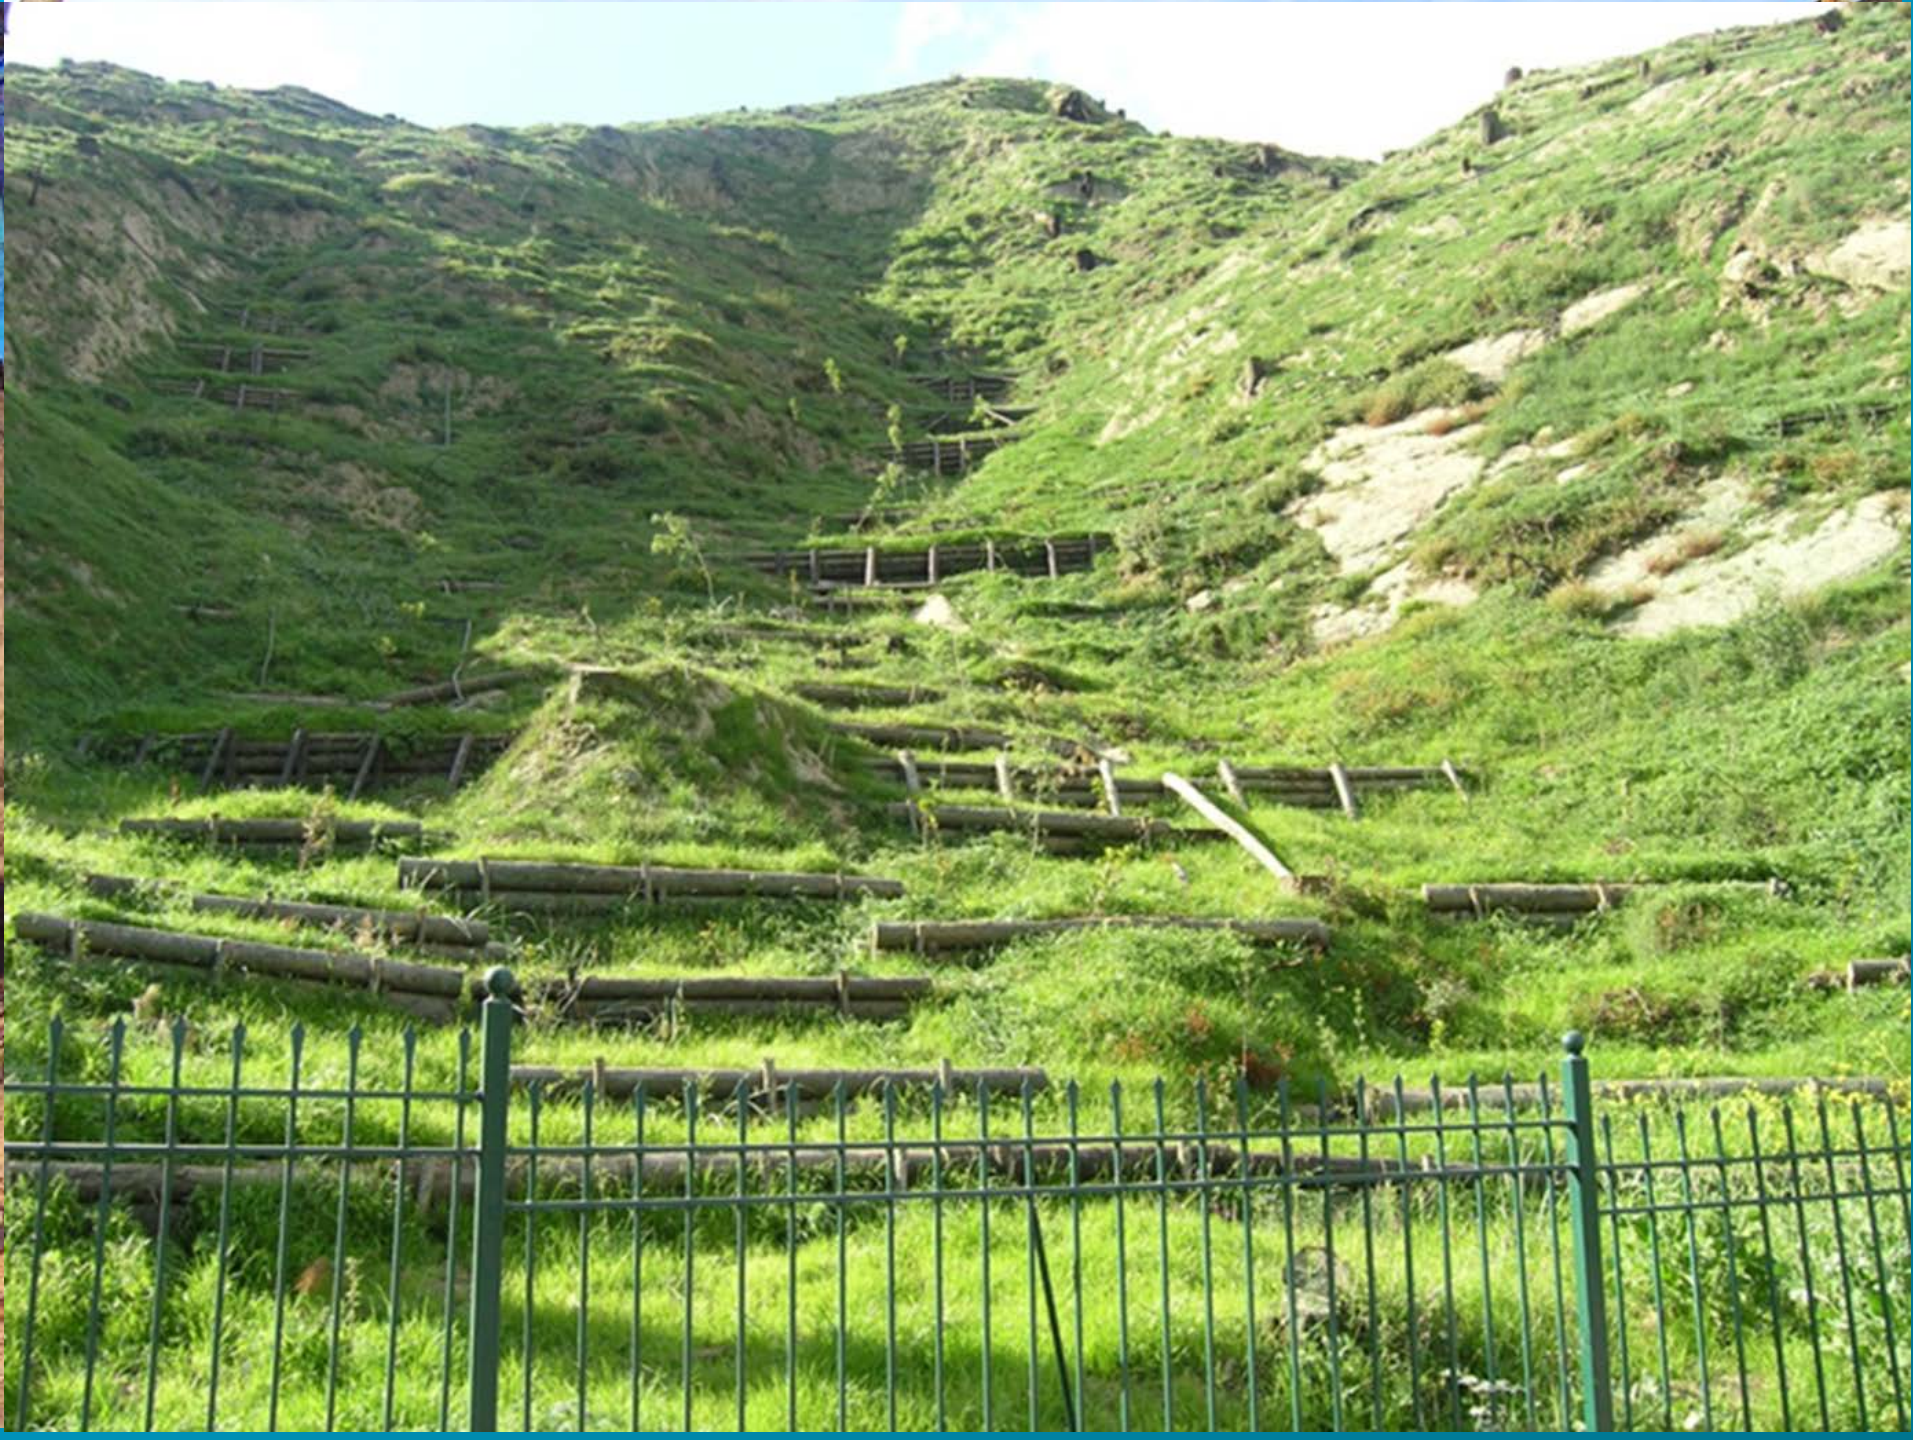
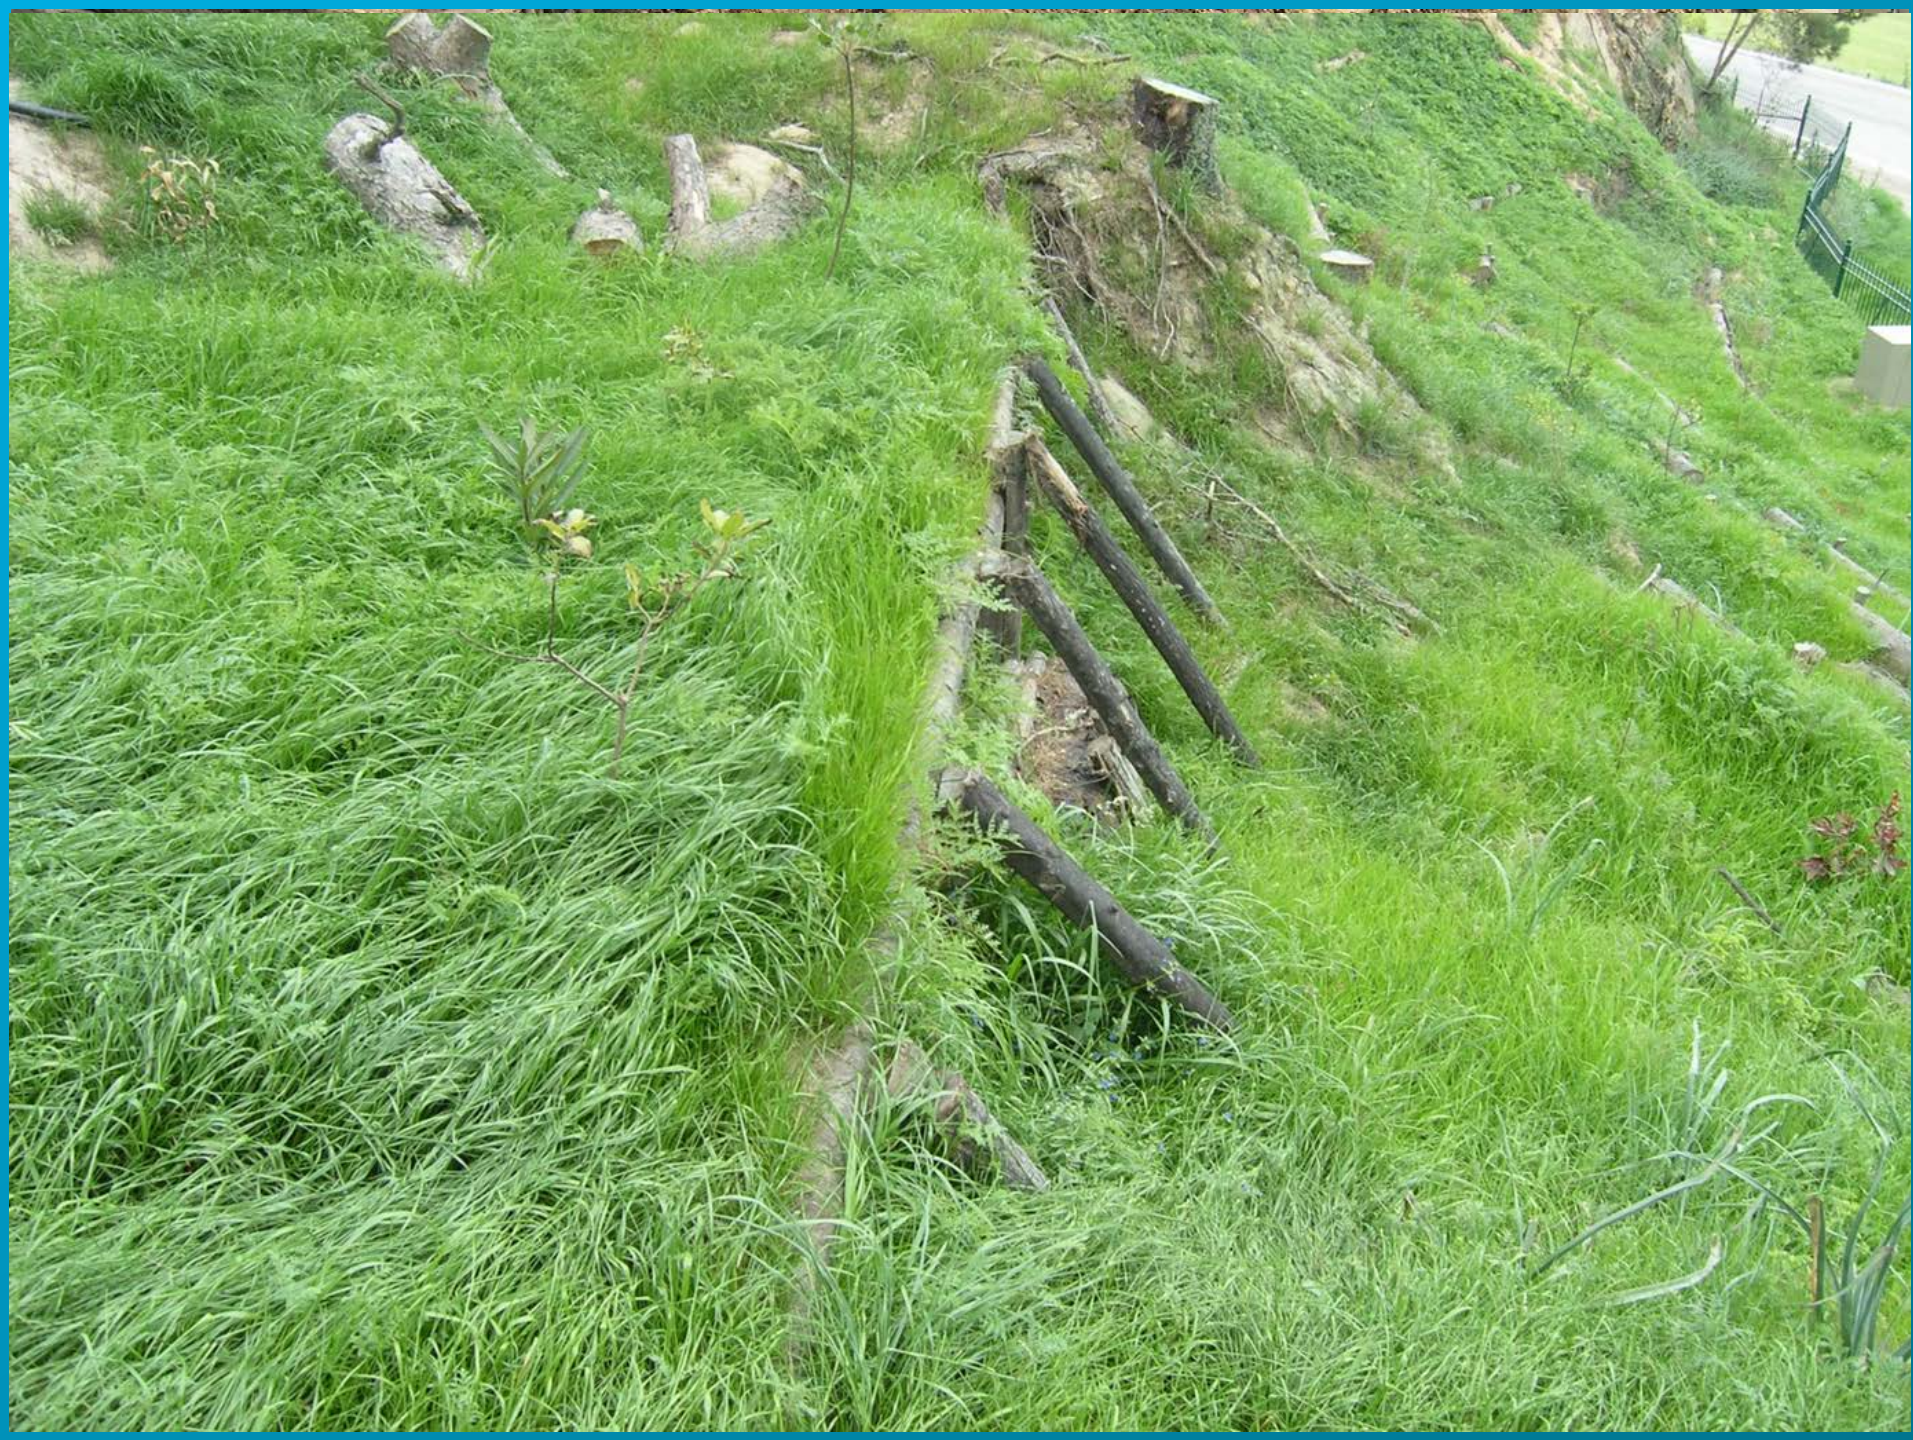
Post-fire natural regeneration

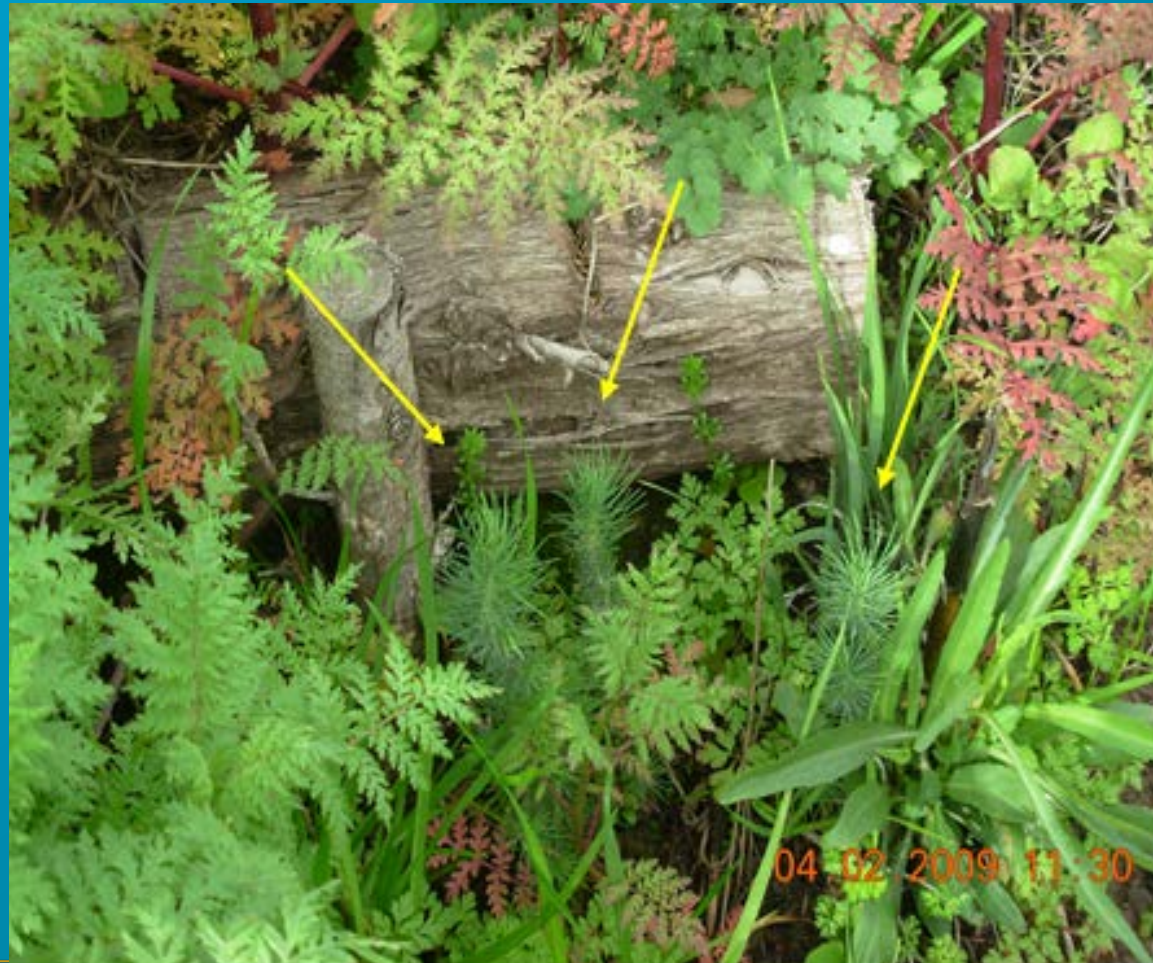
After the onset of the first postfire rainy season (November 2007), the Aleppo pine postfire regeneration was very satisfactory and the mean pine seedling density reached up to 11.55 ± 0.77 seedlings / m²
